Technical Note N-662

UNDERWATER MOORING SYSTEM

7 April 1965

U.S. NAVAL CIVIL ENGINEERING LABORATORY
Port Hueneme, California

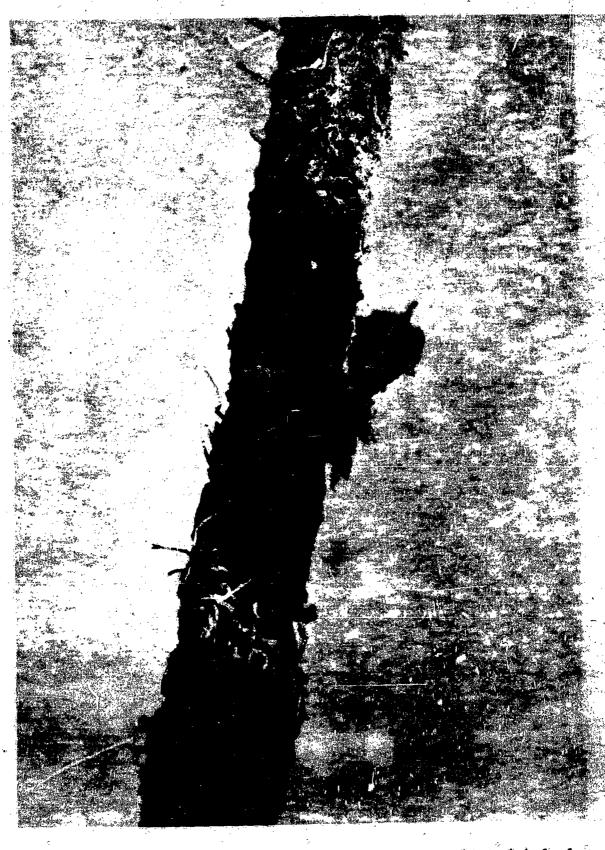
Figure 28. Close-up of the condition of unprotected mild steel shaft of slipring.
